## Test Report

No. CANEC1818312902

The following sample(s) was/were submitted and identified on behalf of the clients as : 7613T

**Halogen**

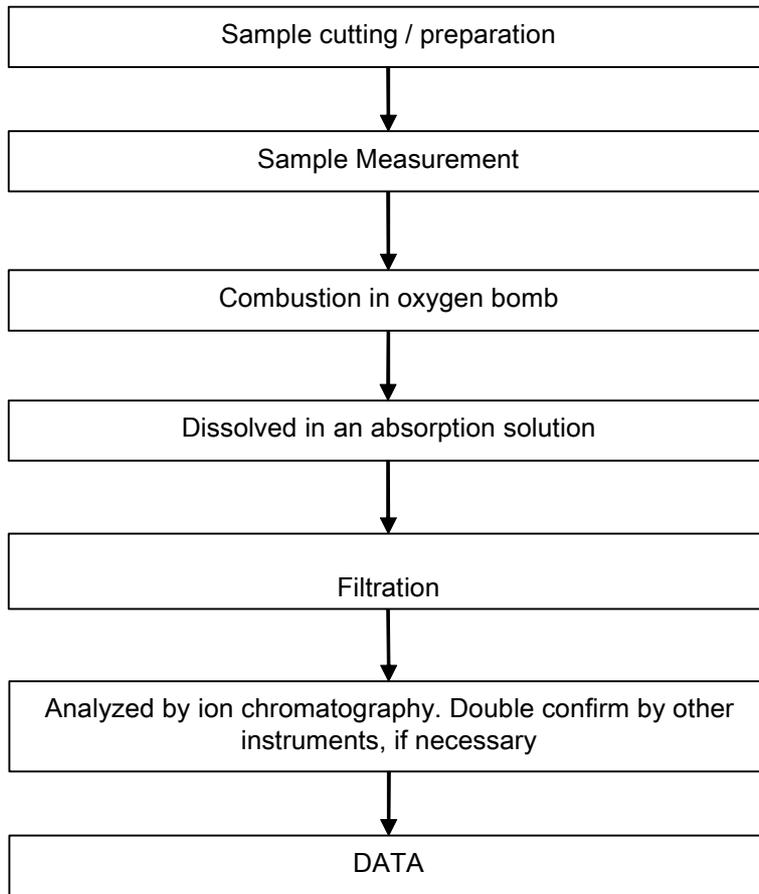
Halogen Testing Flow Chart

Test Method : With reference to EN 14582:2016, analysis was performed by IC.

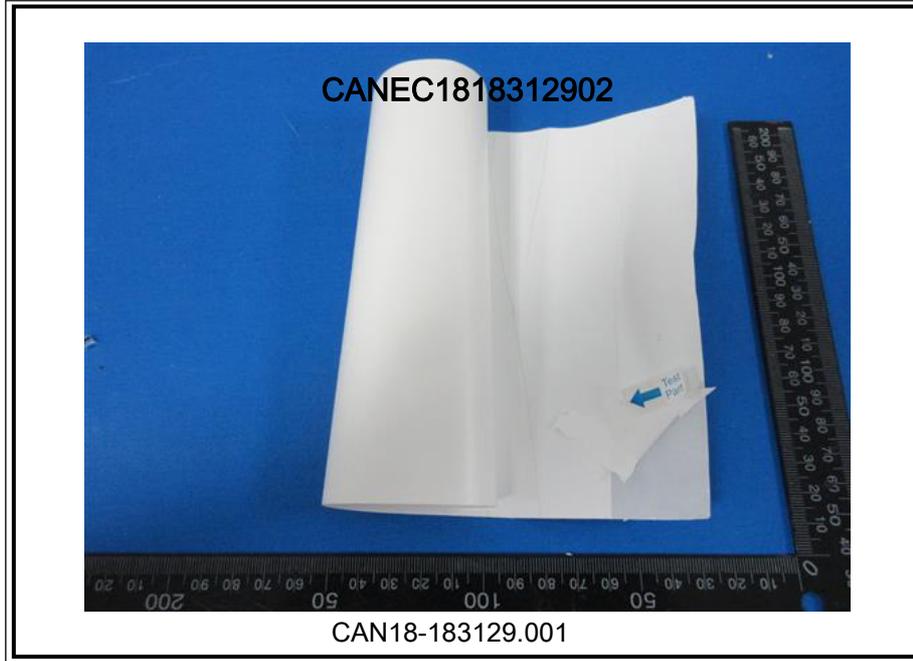
Sample photo:

Specimen No.	SGS Sample ID	Description
SN1	CAN18-183129.001	White adhesive sheet
