Test Report

No.: SHAEC23013074303

Sample Name: 3M 7847

Halogen

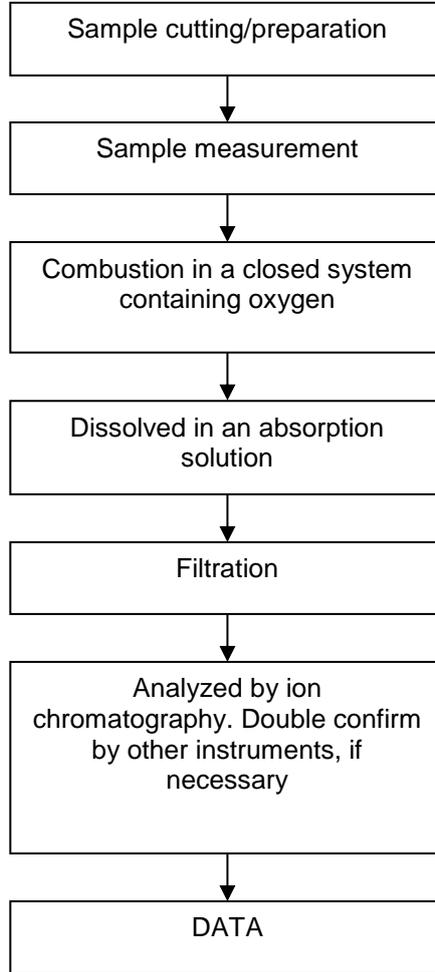
Halogen Testing Flow Chart

Test Method: With reference to EN 14582:2016, analysis was performed by IC.

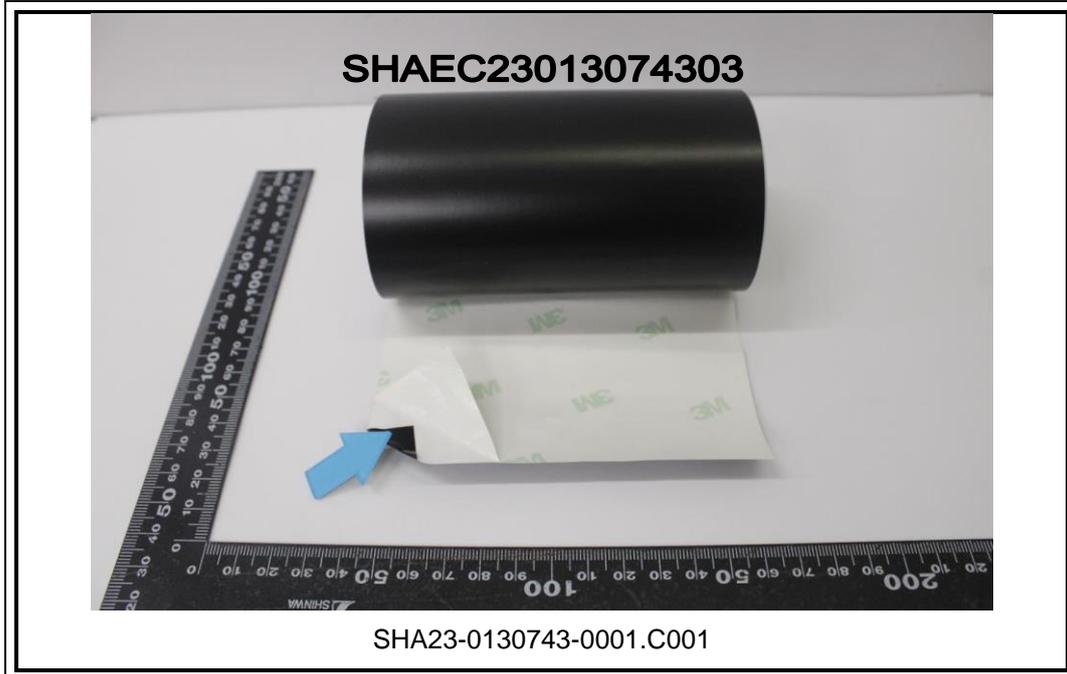
Sample Photo:

SN ID	Sample No.	SGS Sample ID	Description
SN1	A1	SHA23-0130743-0001.C001	Black/white adhesive tape
